## APPENDIX I

### CONCRETE TESTING

RE: Peavey Plaza Fountain Rehab  
Nicollet Mall  
Between 11<sup>th</sup> and 12<sup>th</sup> Streets South  
Minneapolis, Minnesota  
Thin Section Analysis  
AET Project No. 05-06658

## SITE VISIT REPORT

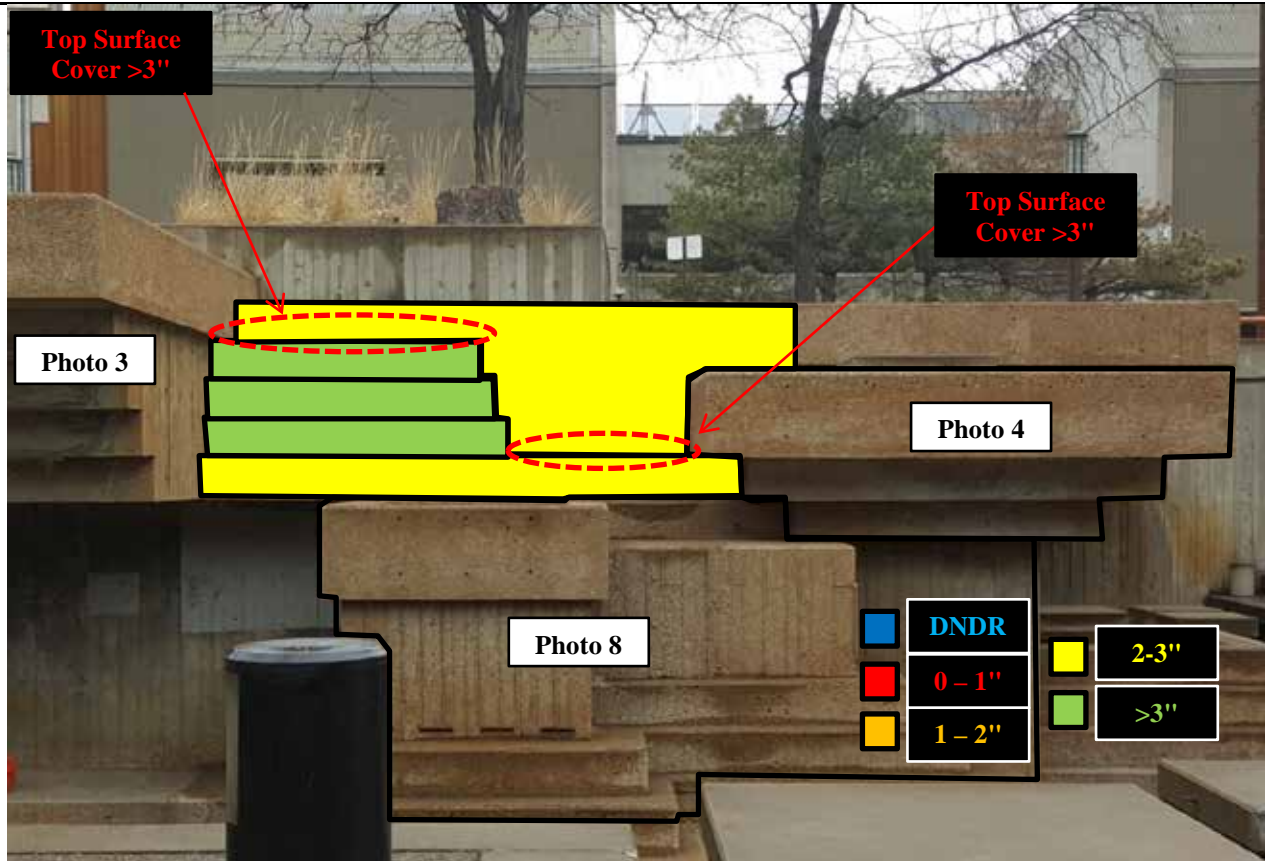
**Photo 9:** Top of south "fountain steps" in southeast corner of fountain.

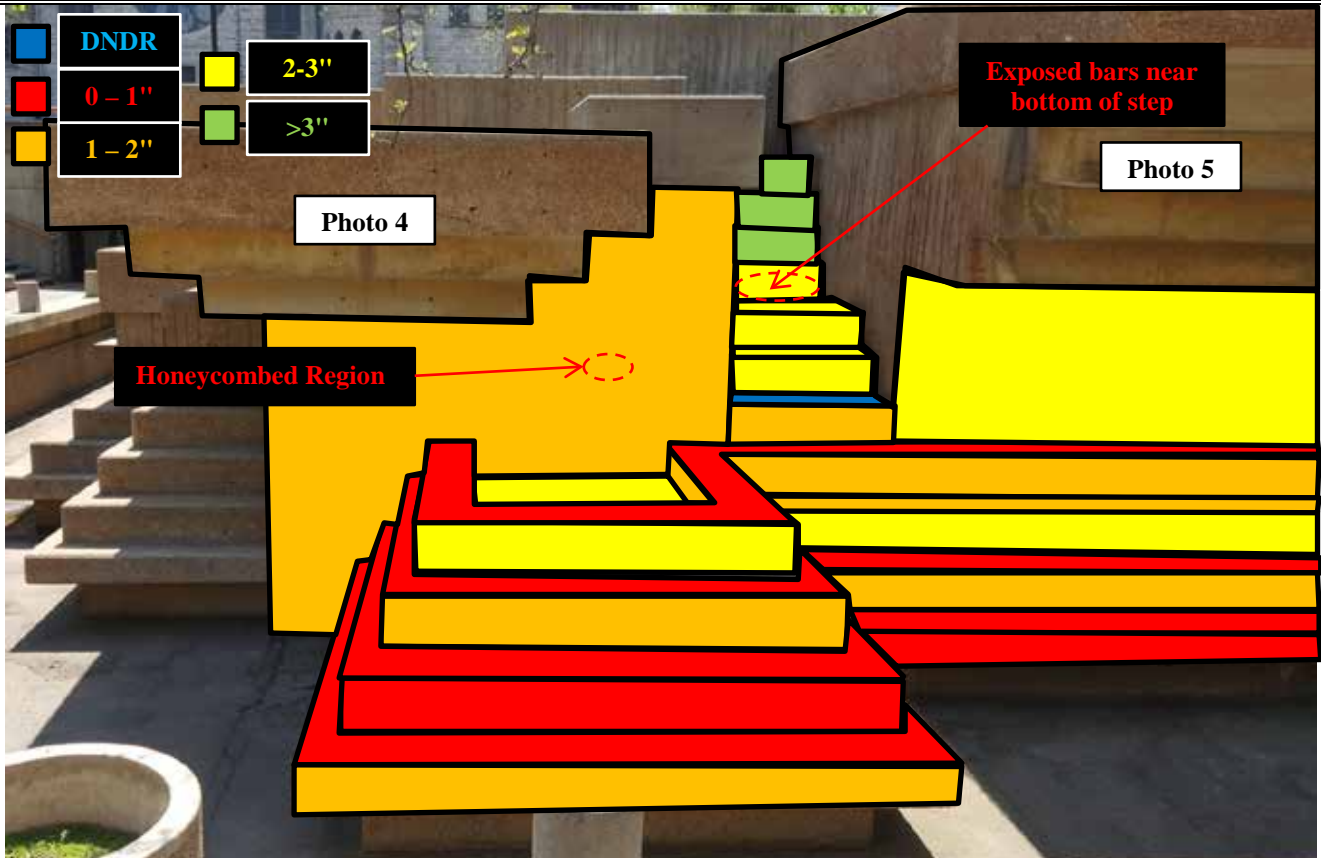
**Photo 10:** Facing 12th Street South towards the east "fountain steps" in the southeast corner.

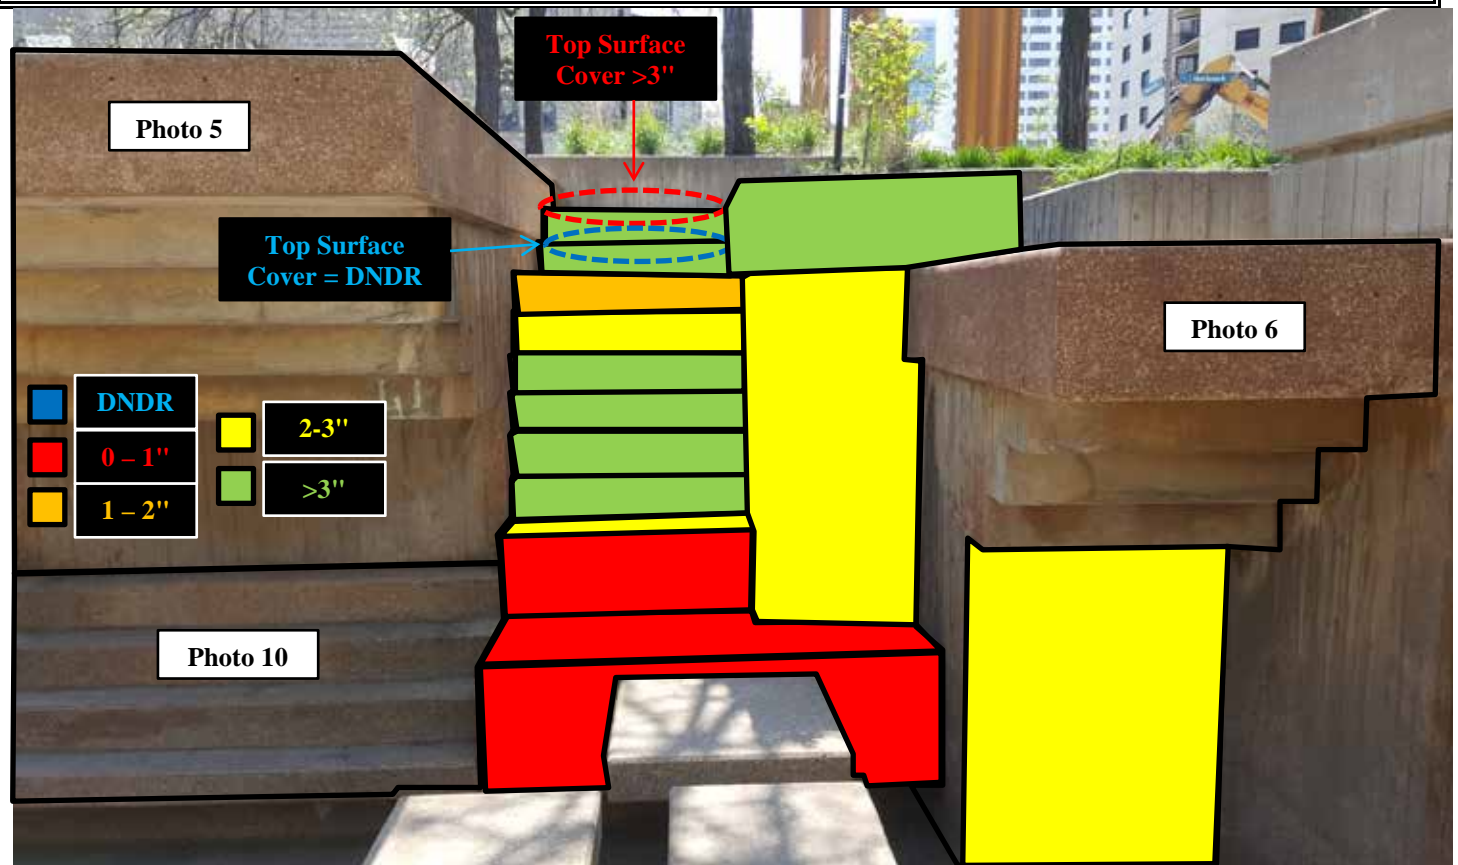
**Photo 11:** Facing 12th Street South at the northeast "fountain steps" in the northeast corner.

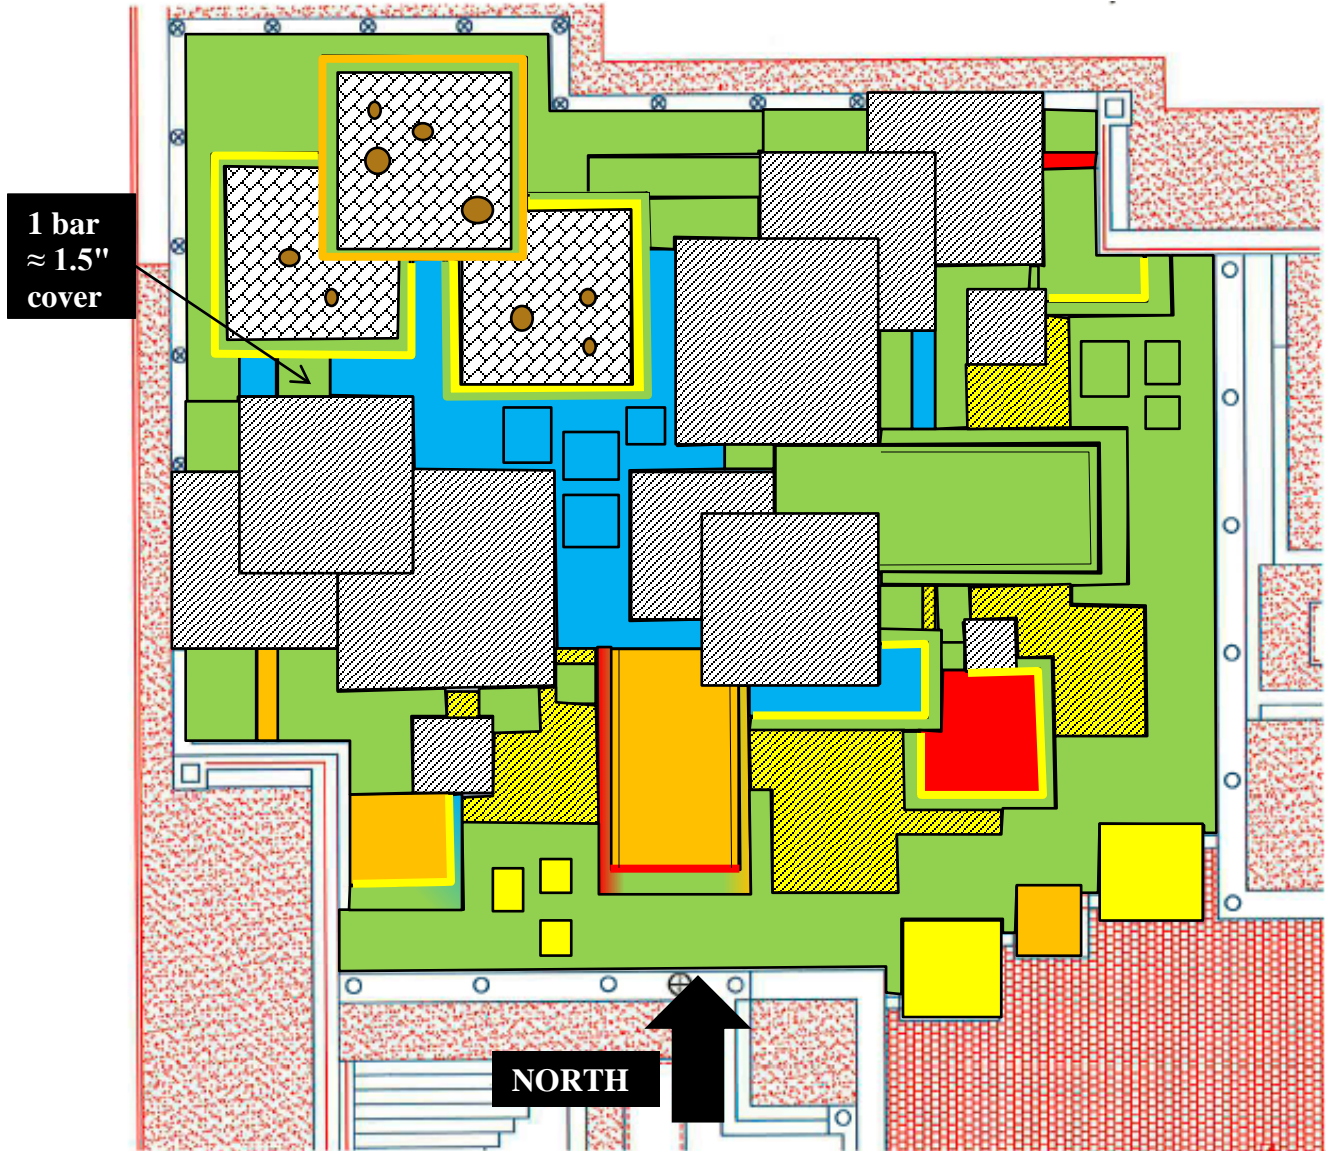
**Top View Diagram – Main Fountains:** DNDR – Did Not Detect Reinforcement, DNR – Did Not Radar, RCPP – Reinforcement Cover in Previous Photos
